## **Problems with Lead-Free Soldering**

The boards of 6 different companies were tested

### **Reliability testing:**

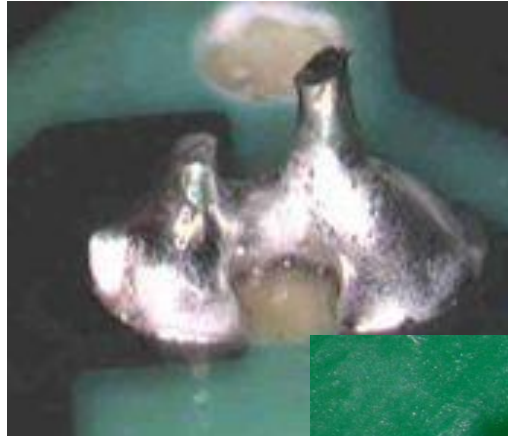
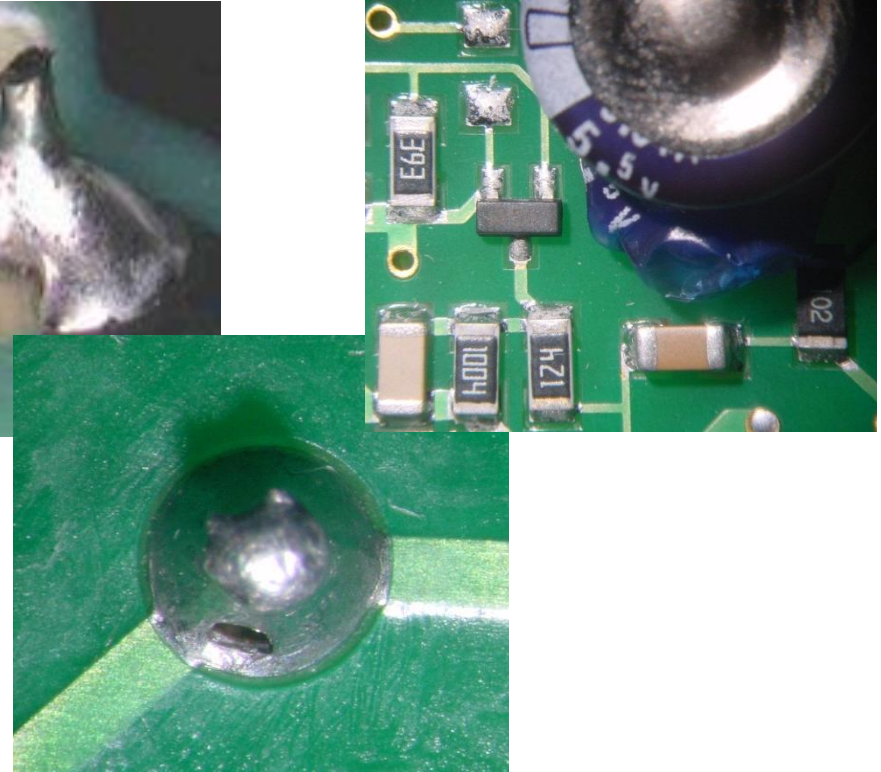
Before testing:

- ☐ Open Joint
- ☐ Solder balling
- ☐ Voiding
- ☐ Pad lifting
- ☐ Porosity

- ❑ No major difficulties in LFS process
- ❑ Wave process with higher defect level in the transition
- ❑ Due to corrosion inhibitors, SACX solder showed negative results
- ❑ Detected defects(voids and pad lifting) are common in these assembling processes due to lack of pre-heating or inadequate thermal cycles
- ❑ Most of the samples had a good reliability, except in thermal fatigue tests.

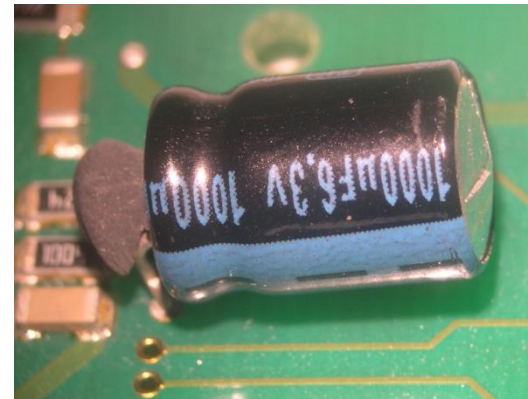
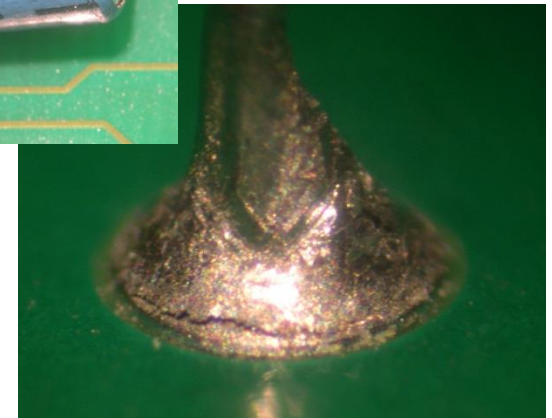
- ❑ Thermal cycling test
  - 59% Sn/Pb e 49% LF did not pass the functionality tests
  - Componentes failure
  - Cracks in the joints
  - Damaged components
  - Degradation

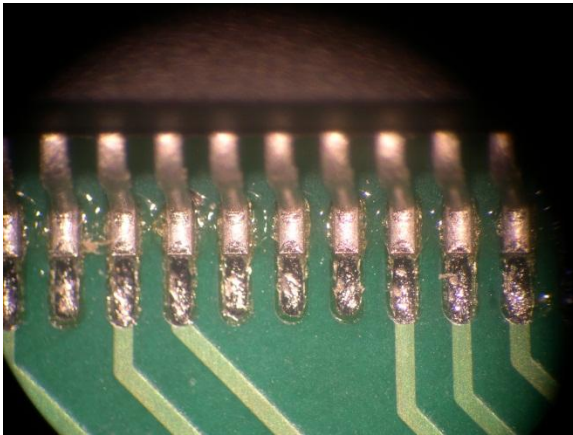
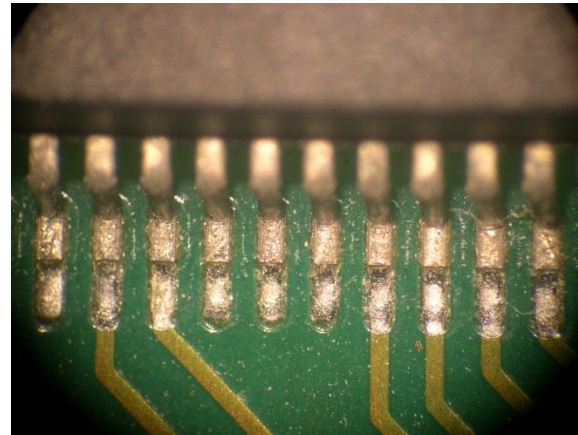
- ❑ Thermal shock test
  - 0% Sn/Pb e 11% LF did not pass the functionality tests
  - Without visible defects
- ❑ Vibration tests
  - All the boards have passed in the electrical functional test

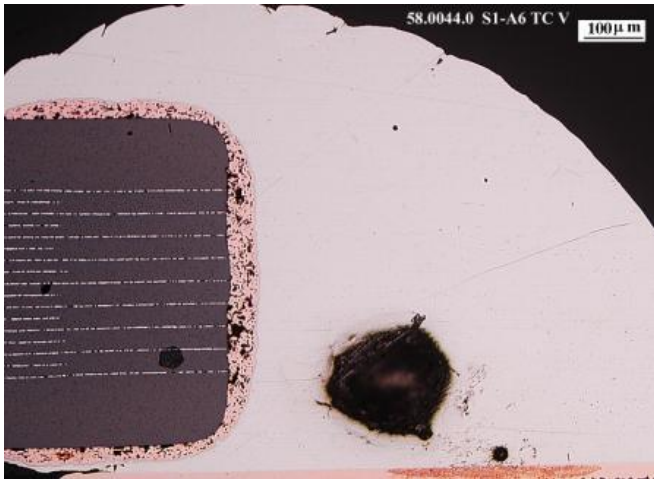
Board C, Reflow, 62Sn/36Pb/2Ag,  
Thermal Cycles

### ❑ Voids

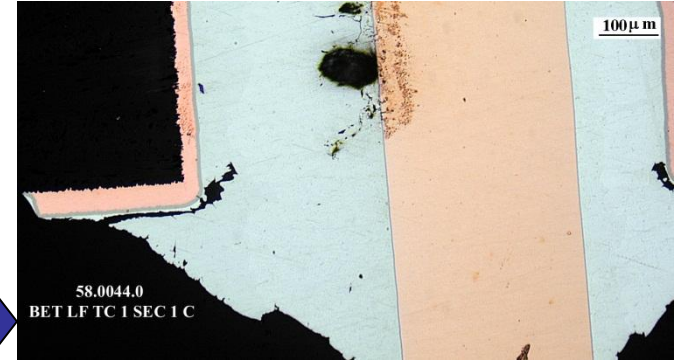
Board F, Wave, Sn/Ag/Cu/Bi, Thermal Cycles

### ❑ Cracks

- ❑ SMD had lower damage level than “through-hole” samples and mainly due to the assembling process.
- ❑ Cracking on “through-hole” samples are far from the interface, without significant propagation, showing good results in both Pb/Sn and LFS joining.
- ❑ Most of the defects can be avoided and do not introduce integrity and functionality risks .
- ❑ Damage in Pb-Sn and LFS are similar
- ❑ In general LFS samples showed good performance

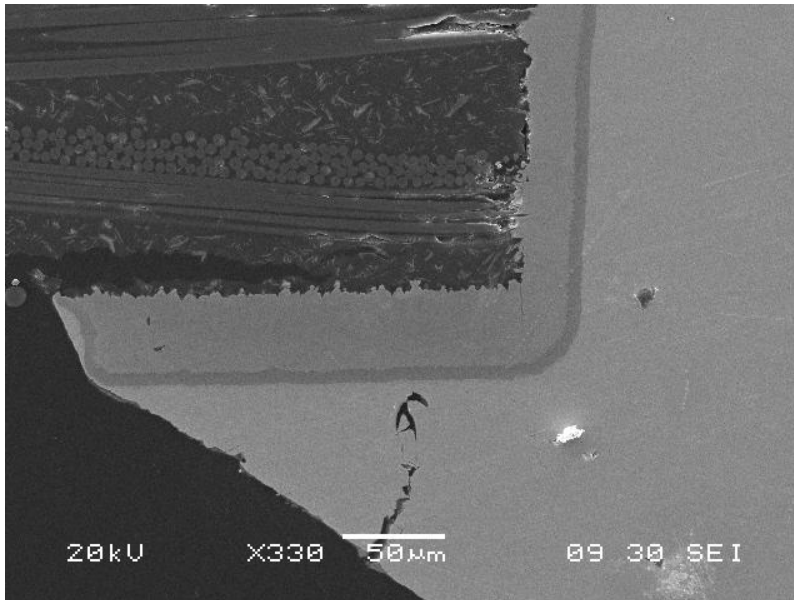
- ❑ Lift of the contact with the board

<i><b>Material</b></i>	<i><b>CET (x10<sup>-6</sup>/K)</b></i>
<i>Sn</i>	<i>23.5</i>
<i>Ag</i>	<i>18.9</i>
<i>Cu</i>	<i>17</i>
<i>Ni</i>	<i>13</i>
<i>Pb</i>	<i>29</i>
<i>Cu<sub>3</sub>Sn</i>	<i>18.4</i>
<i>Cu<sub>6</sub>Sn<sub>5</sub></i>	<i>20</i>
<i>Laminated</i>	<i>17</i>
